**Flood Control Project Maintenance  
Levee Inspections  
LMA District Cover Sheet  
Spring 2010 Levee Inspection Results**

**Sutter Maintenance Yard East Levee Sutter Bypass**

**Levee Inspection Report By Mile - Spring 2010**

Waterway				Bank	Unit Miles	Inspection Start/End	Inspector
Unit No. 01 Sutter Bypass Levee				Left	22.12	03/24/2010 03/24/2010	Bob Duffey

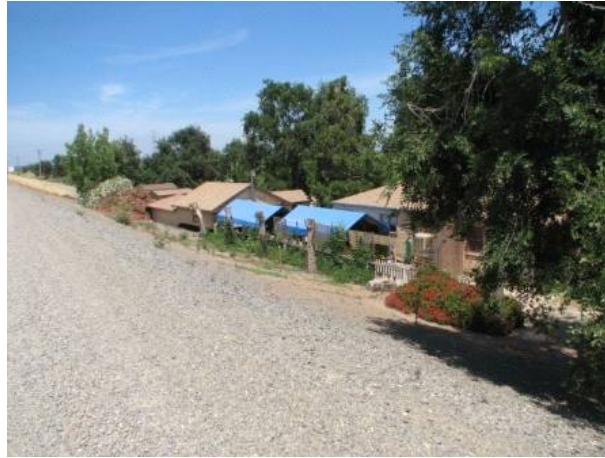
rduffey\_s\_20100625\_078.jpg

Levee Mile Report Line	8
Start Levee Mile	20.64
End Levee Mile	20.64
Location	Land Side
Category	Earthen Levee
Item	Encroachments

View of the building next to the landside toe of the levee.
